1. AGENCY USE ONLY (Leave blank)	2. REPORT DATE 10/00/91	3. REPORT TYPE AND DATES COVERED	
4. TITLE AND SUBTITLE QUARTERLY WATER-LEVEL MONITORING REPORT, OTHER CONTAMINATION SOURCES, INTERIM RESPONSE ACTION, SOUTH TANK FARM PLUME		5. FUNDING NUMBERS <div style="border: 1px solid black; border-radius: 50%; width: 40px; height: 40px; text-align: center; line-height: 40px;">1</div>

SOUTH TANK FARM PLUME

October 1991

ROCKY MOUNTAIN ARSENAL
South Tank Farm Area

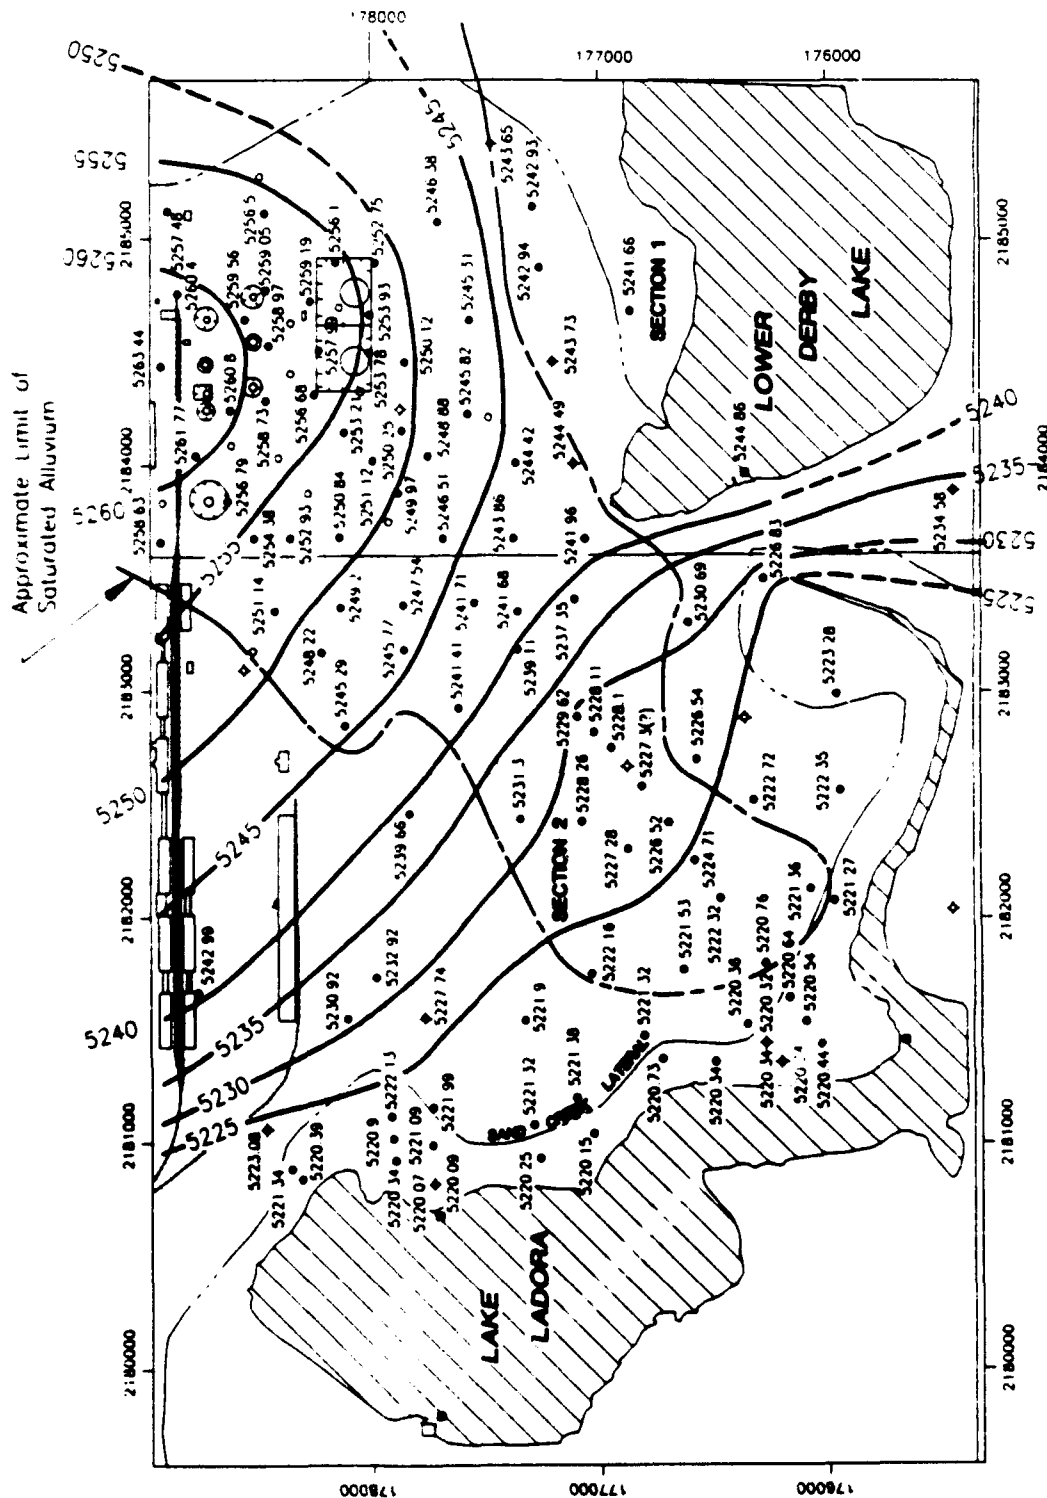
Figure 1

The results of the September 1991 water-level measurements are illustrated by the water table contour map shown by Figure 1. The general groundwater hydrology has changed since June 1991 (Figure 2), as shown on Figure 3 which gives the change in water-level for each well. However, the groundwater flowpaths have not changed, nor has the effect of Lake Ladora on the local groundwater.

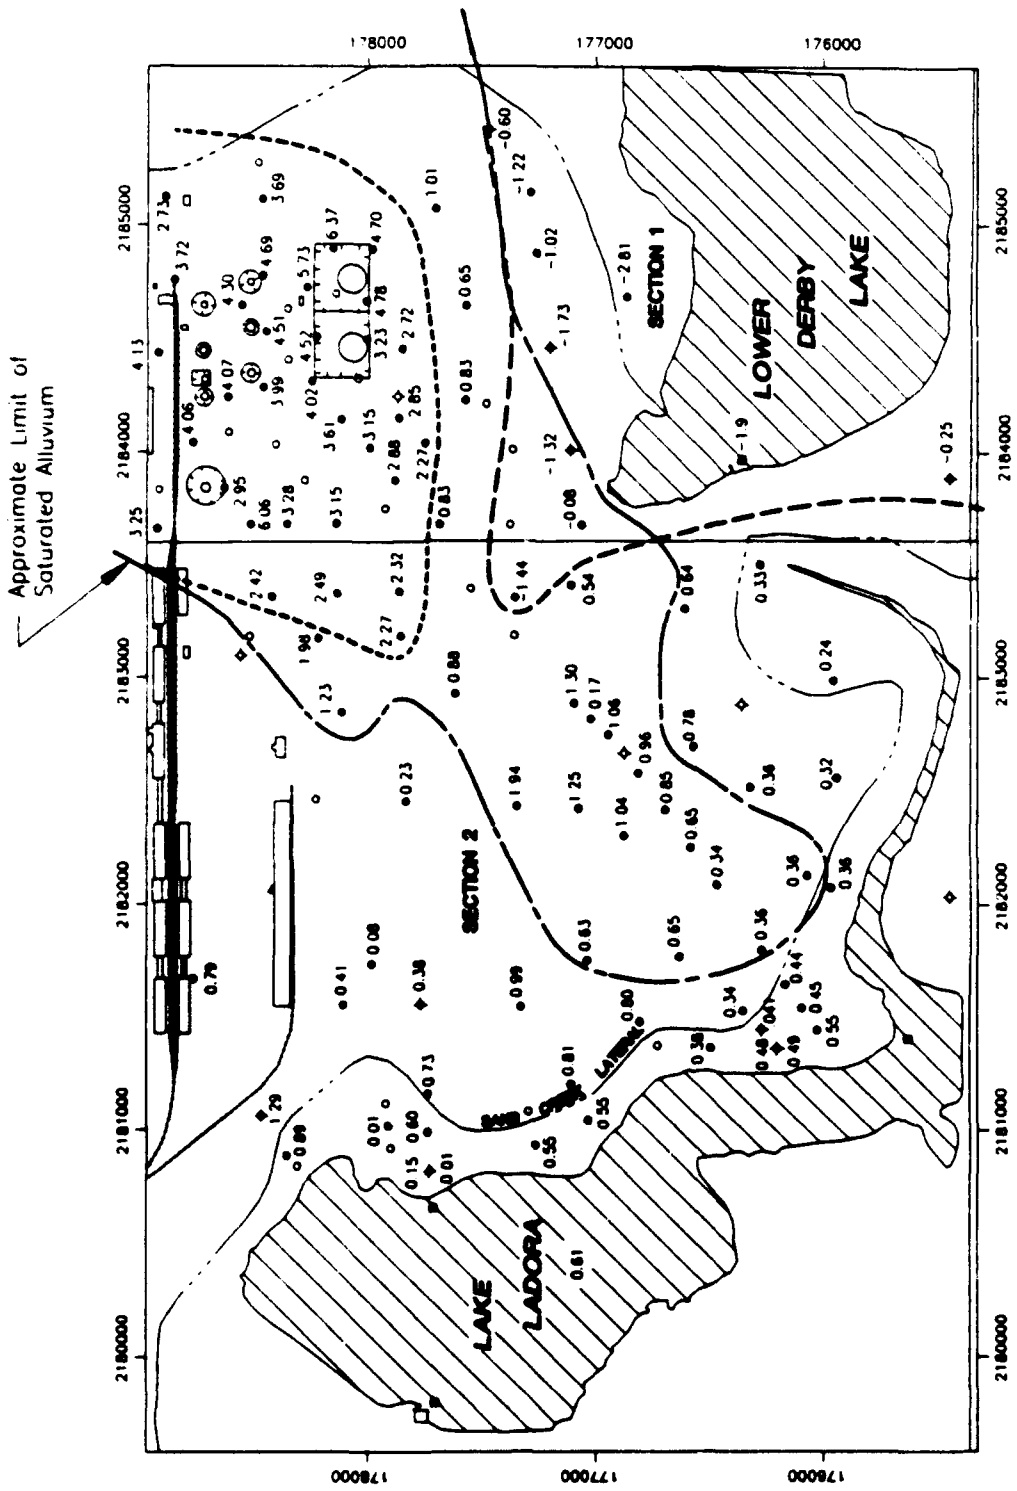
Figure 3

Water-levels in the tank farm have risen over 2 feet since the last quarter. This increase in water table elevation is most likely due to a combination of the heavy precipitation which has occurred during the summer and a water line break which occurred near Building 316A in August and was not repaired until mid-September.

Water-levels in Lower Derby Lake and the wells adjacent to the lake have declined since last quarter. This is due to the lowering of the lake in order that repairs to sections of rip-rap may be made. The Army started lowering the lake in early September.

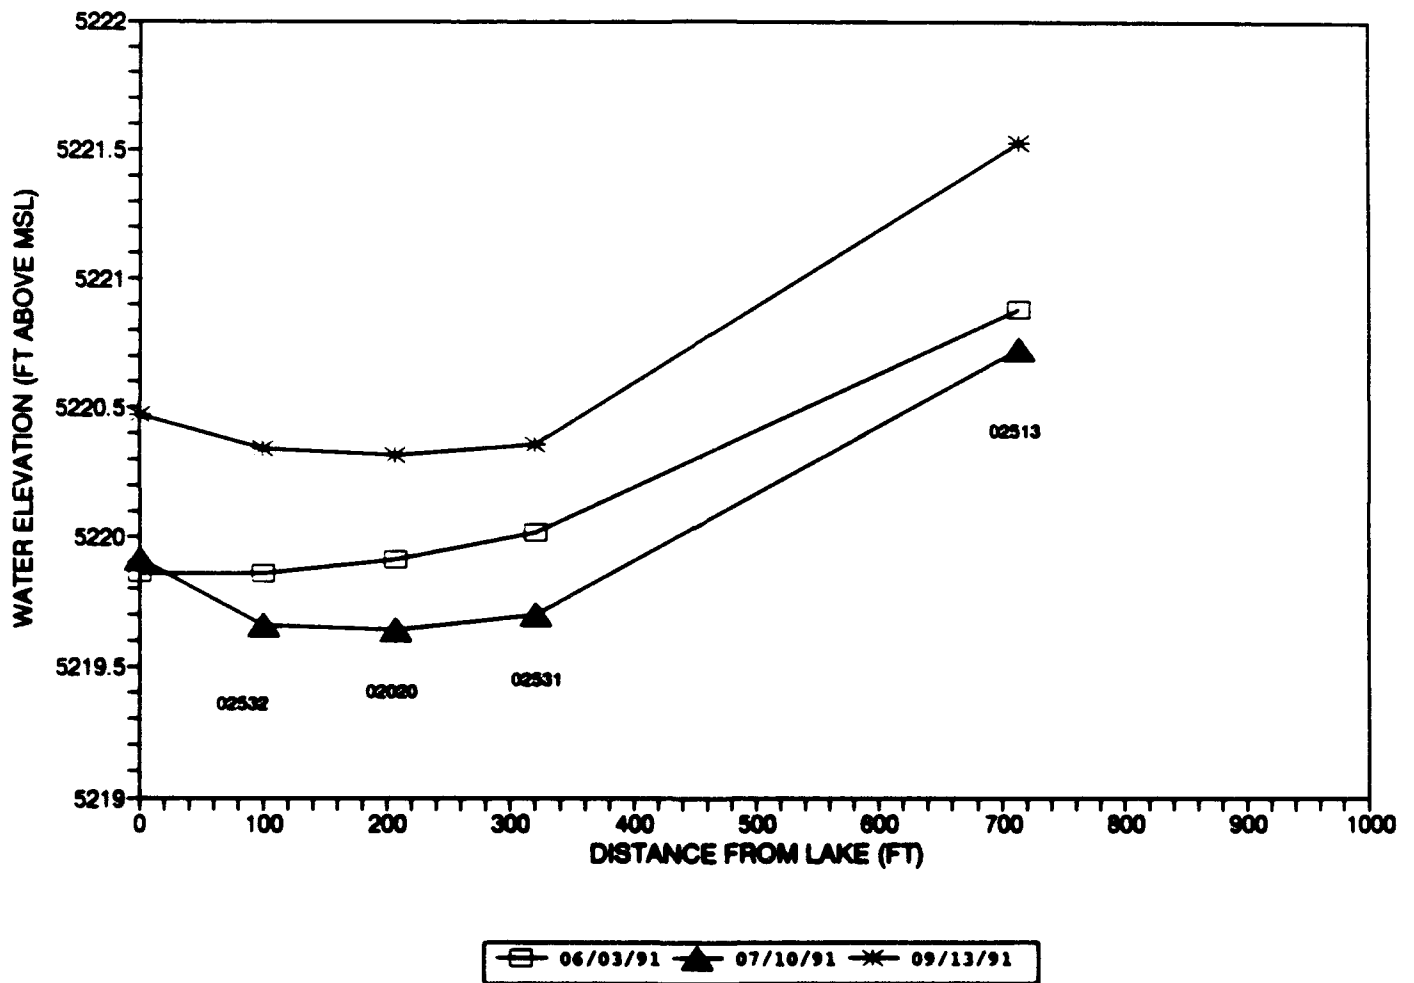
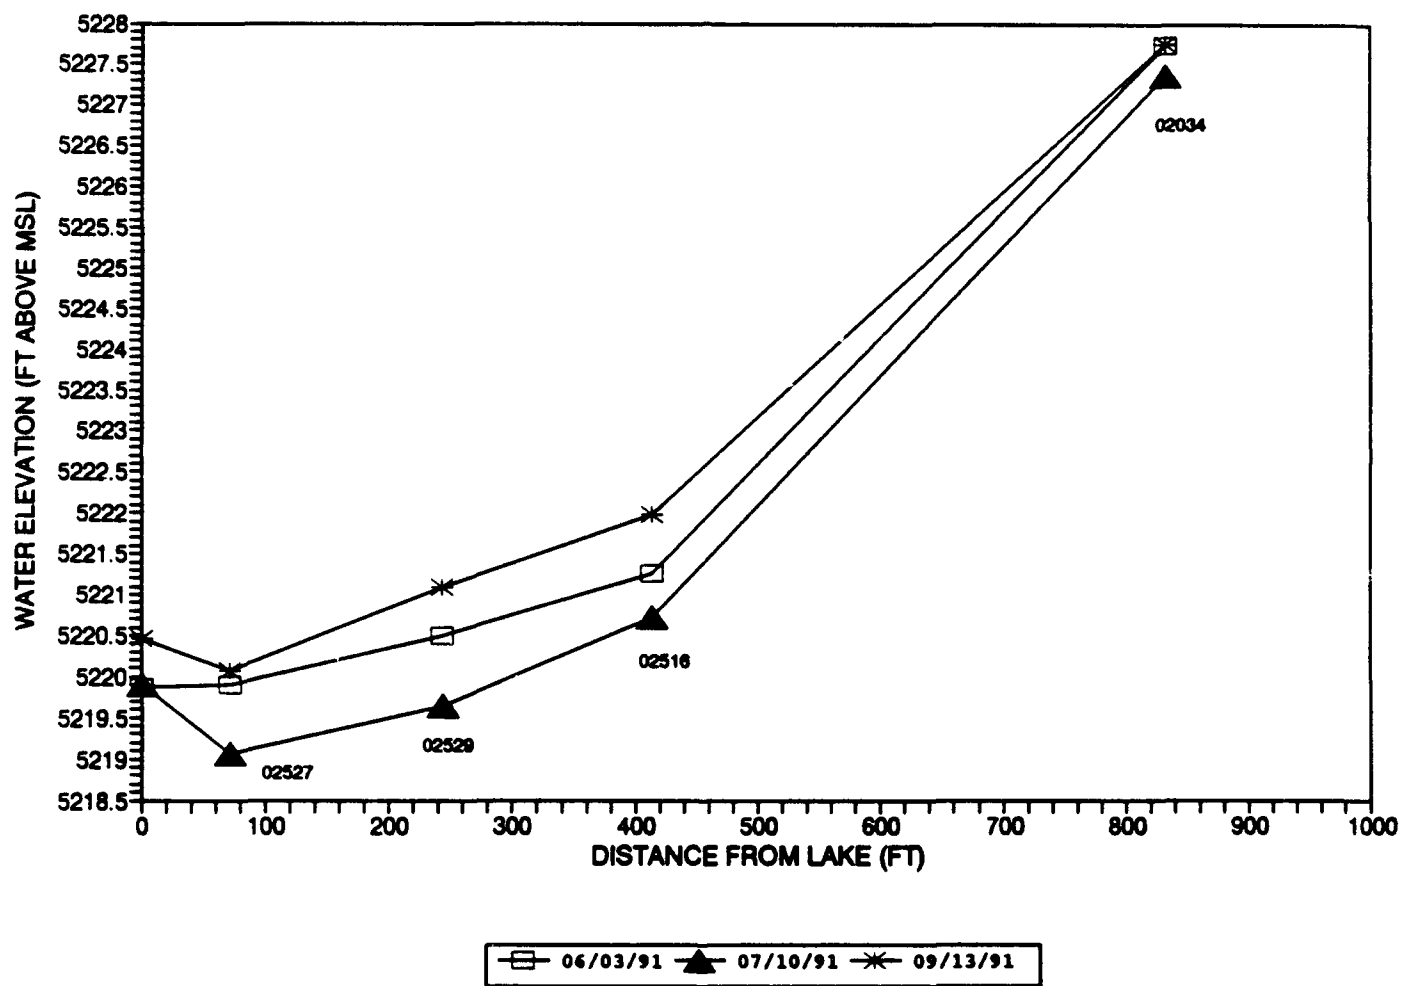
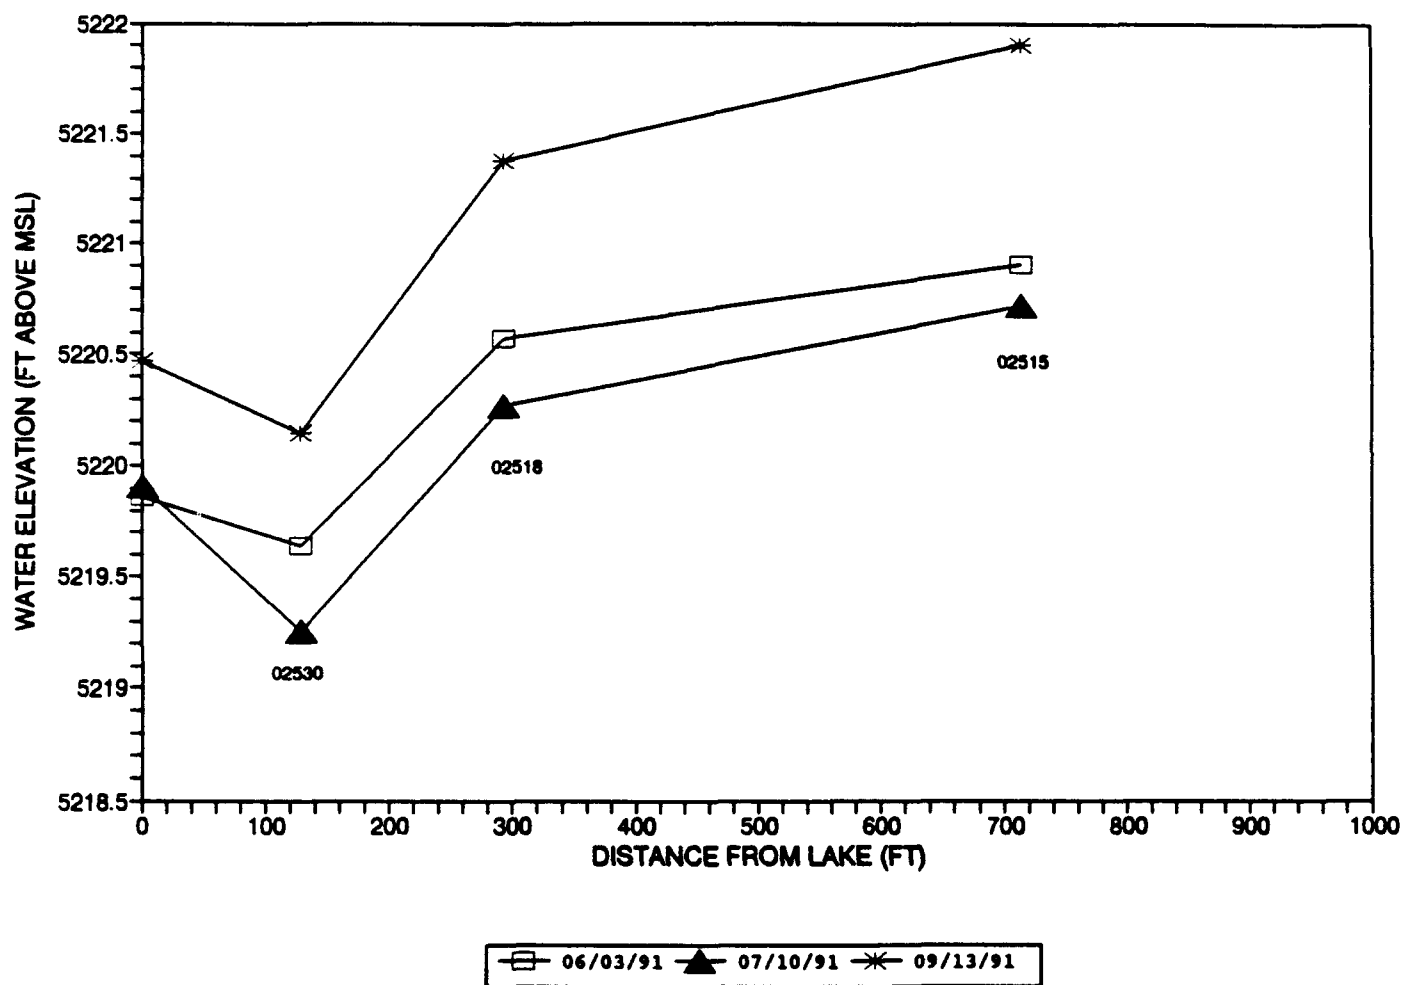
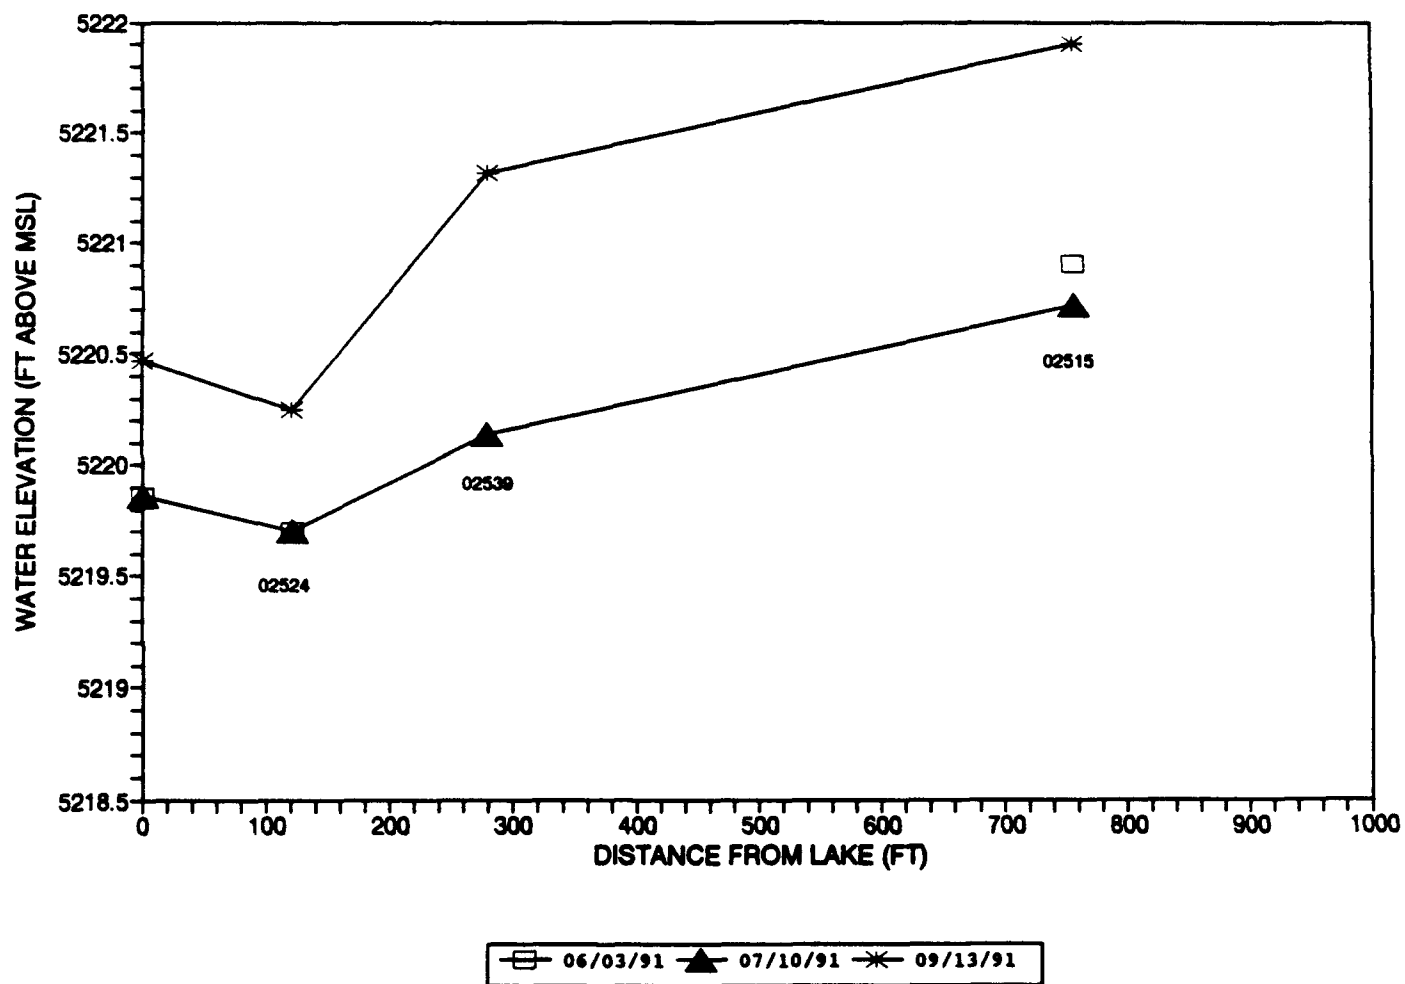
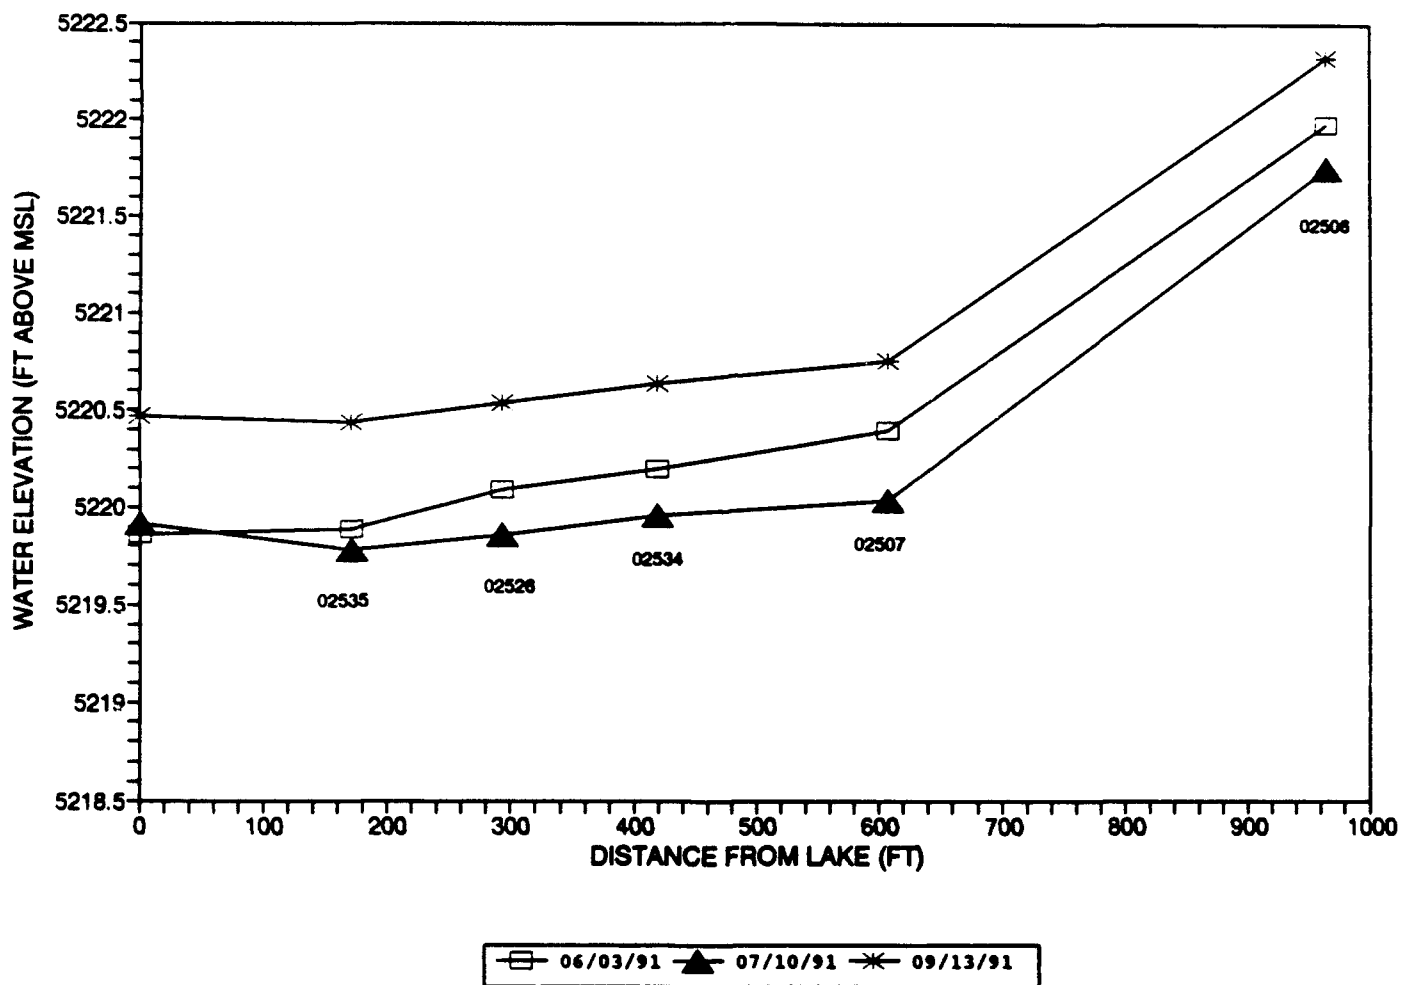
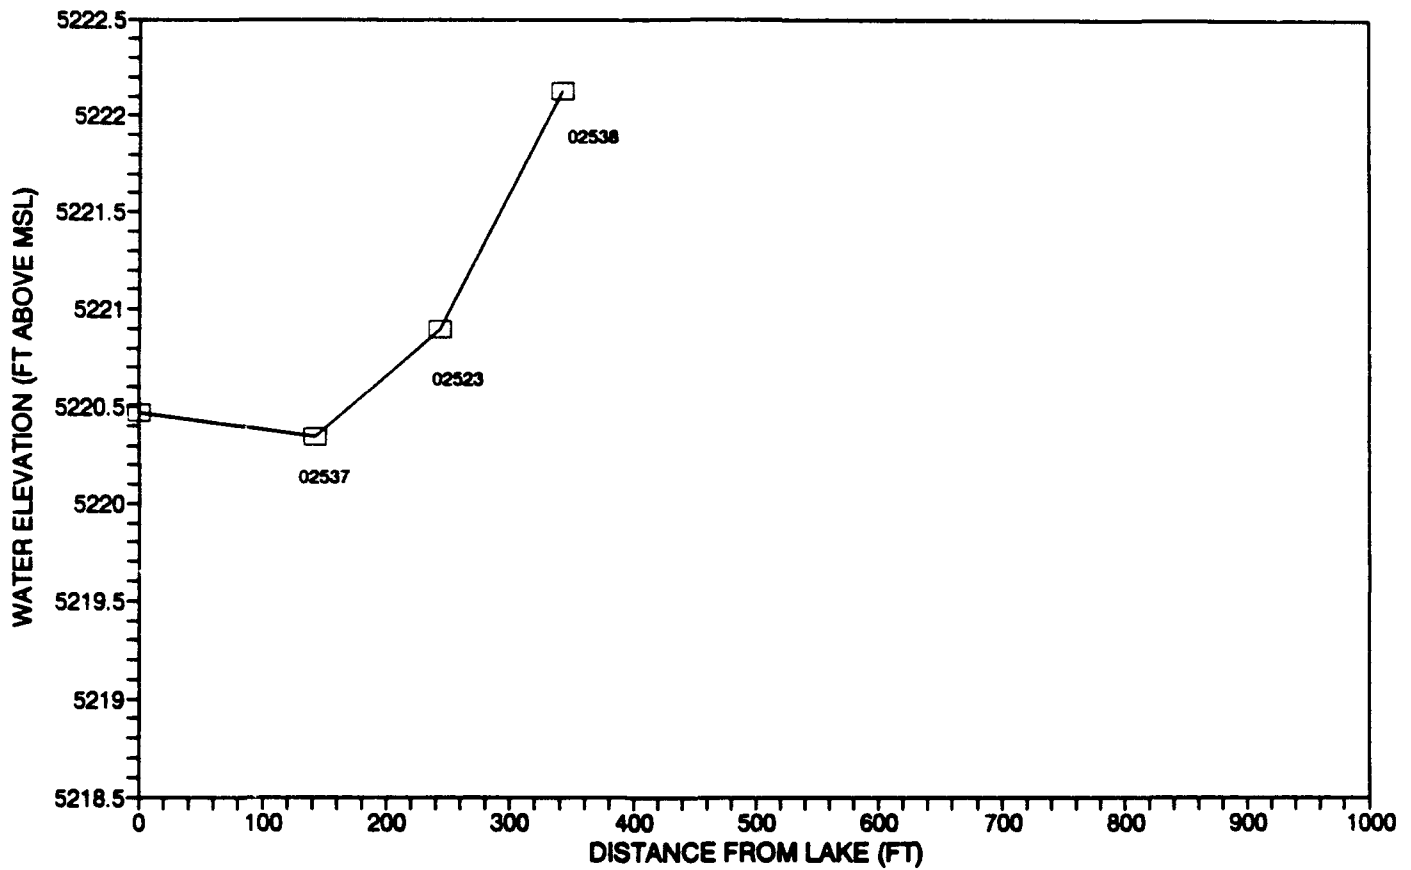
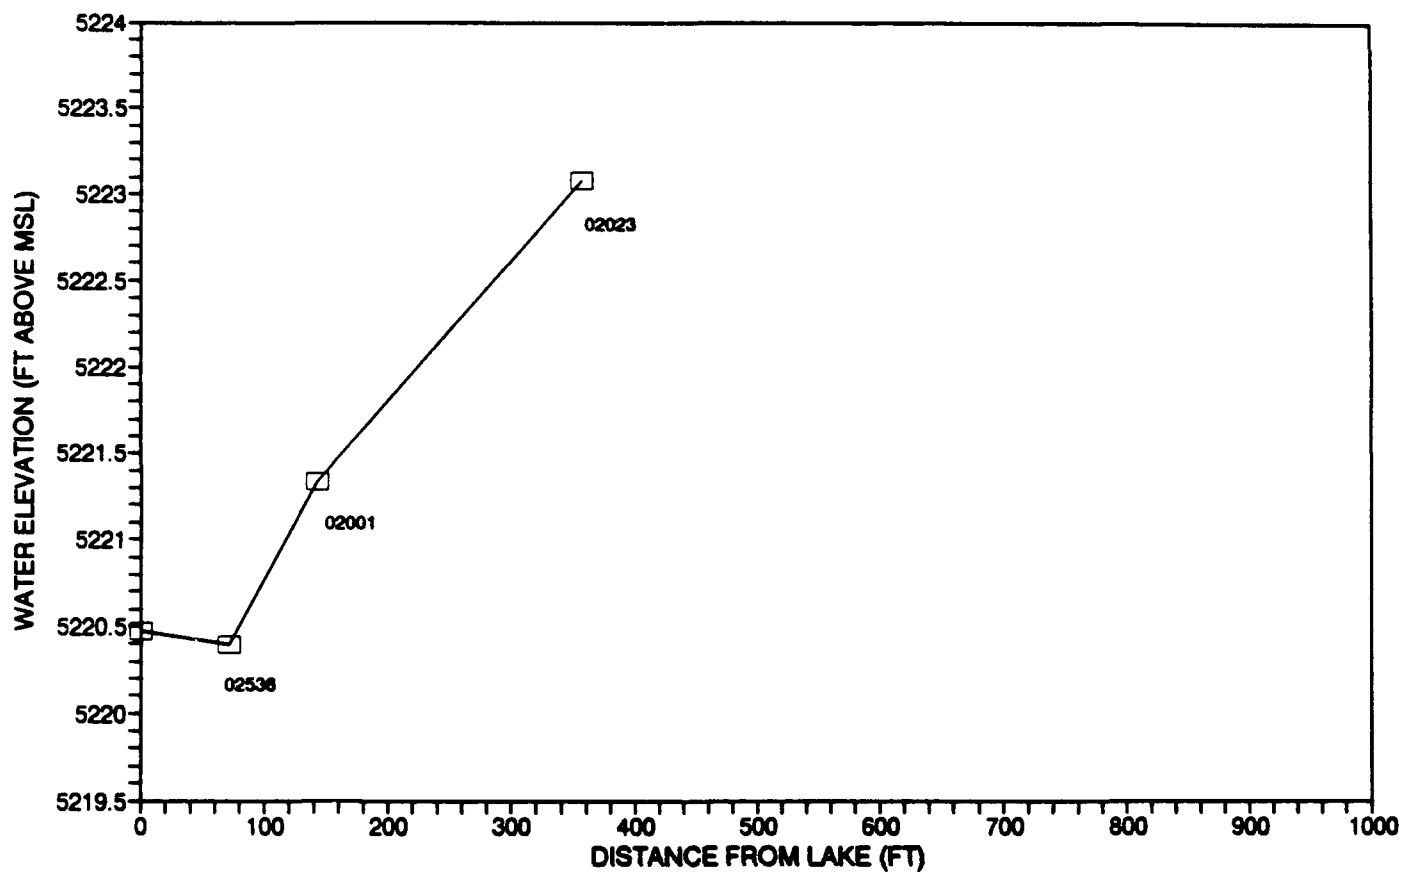
The most recent water-levels in Lake Ladora and the wells nearest the lake exhibit similar patterns to those observed during June and July 1991 (Figures 4 through 10). Water-levels in this area have increased slightly (less than 0.5 feet) since last quarter due to the heavy precipitation received during this summer. At the beginning of August, Sand Creek Lateral was full of flowing water along the entire length of Lake Ladora. In addition, Figure 11 shows that the Army has been maintaining the level of Lake Ladora at an elevation of approximately 5220 feet or above.
